The 'Lockdown' Challenge

Challenge Images No. 13 — Numbers 157 to 169

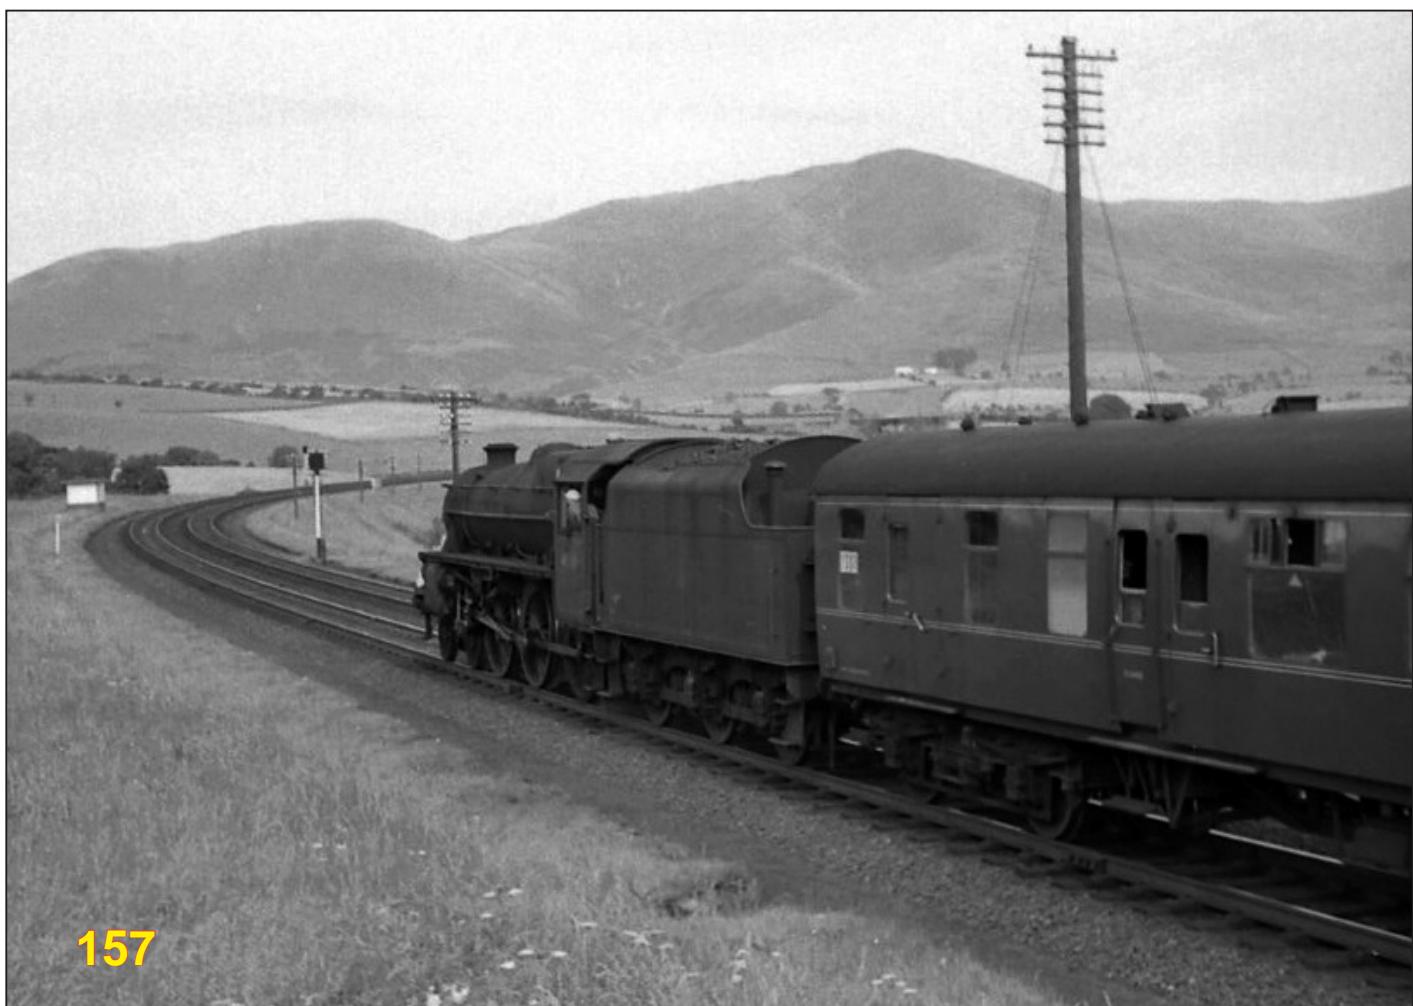
Challenge No. 157

Graham Worsnop advised that the photo was taken by Peter Robinson (020c02) of LMS 5MT 4-6-0 45101 working a Down passenger train south of Low Gill on 28th July 1963.

John Pickup agreed with David on the location, but didn't think that the state of the trees in full leaf looked like Westmorland in April. John did think that the loco looked mucky enough for the year to be 1966, and it looked as if there was an electrification flash on the firebox just peeping out in front of the cab. John also thought the leading carriage window had the train's reporting

Tony Jenkinson also noticed that the distant signals in the photo (Grayrigg's Up Distant (nearest) and Low Gill's Down Distant (farthest)) had white posts. However, in the 1950s these had black and white painted posts designed to improve sighting during poor weather conditions.

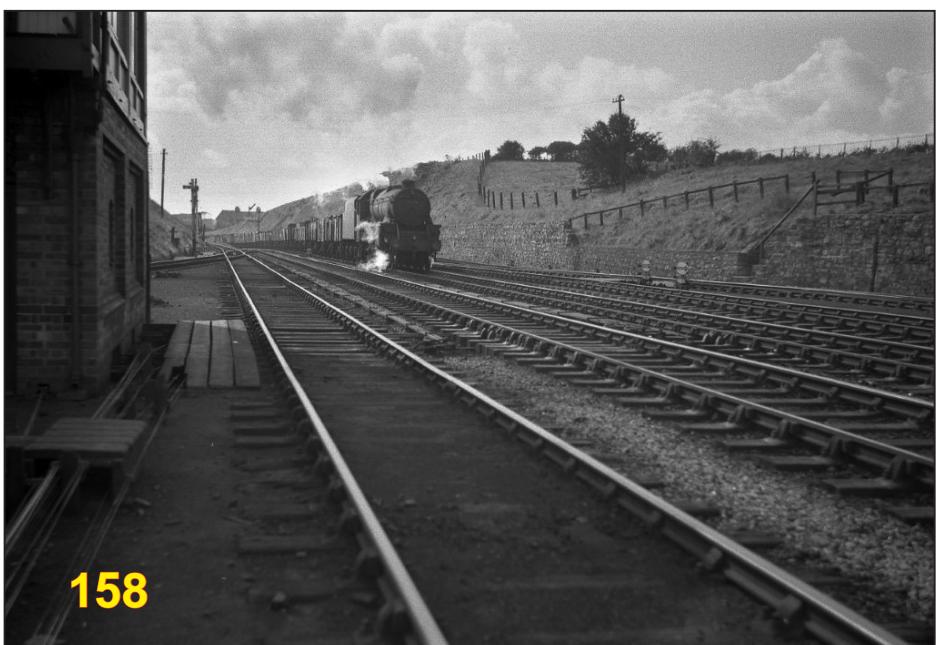
Challenge No. 158

Graham Worsnop advised that the photo was taken by Bill Worden (WOR034) of LMS 5MT 4-6-0 No 45133 working an Up Goods train approaching Lindal Ore Sidings signal box on 14th September 1957.

Derrick Codling advised that one box had to close during the savings made in the 1970s, and, as Ulverston still had an active goods yard, the box in the photo was the one which succumbed to the cuts. **Howard Quayle** confirmed that the closure of Lindal Ore Sidings box was on 6th March 1978, and he seemed to recall that some of the components of the signalling system were German and required specialist S&T maintenance. Les wondered about the 'German barrel' levers actually being from Germany, as he believed they were used elsewhere on the LMS and were installed for points that were too far away from the box for a signalman to pull using the normal levers and rodding. He added that in the Lindal case the points were previously operated by Lindal East box. **Richard Foster** advised that the turnover levers and double wire working with levers, as seen in the photograph, were pretty common in Europe — in many areas frames of this type were the standard, just as lever frames were in the UK. Richard added that they worked perfectly well, hence the reason they are often referred to as 'German Barrel'. The levers work through 180 degrees or more, hence the need for name plates on both sides. The Midland Railway took an interest in the system, because it was considered to have advantages in places like marshalling and goods yards where rapid operation of points was needed to maintain rapid shunting. They developed their own design of turnover lever, and did indeed make whole lever frames of this type for installation in boxes at big yards such as Barrow Hill and Rowsley. The two wire system had the advantage that points could be worked further from the box than with mechanical rodging, so it had a role where points were too far away, or long loops were needed, thus avoiding the

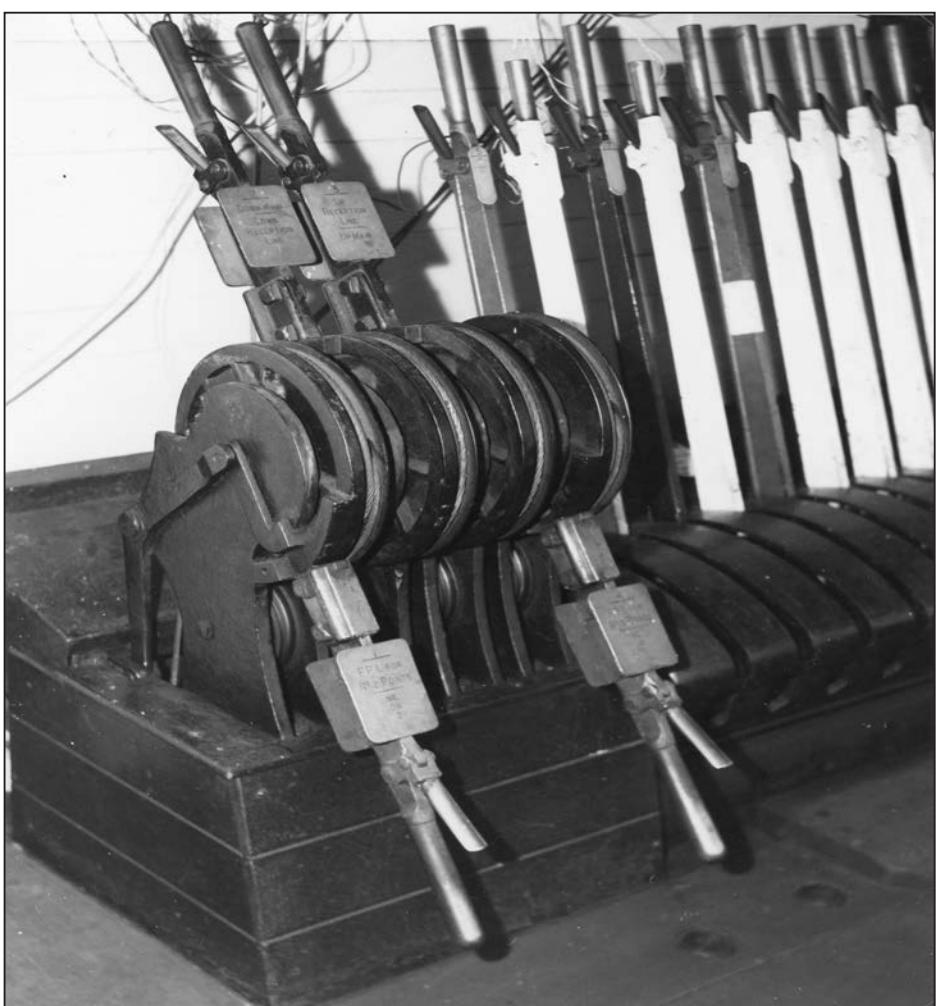
When Lindal East and Lindal West were amalgamated into a new box at Lindal Ore sidings on 26th November 1939 the entrance to the Down loop and exit from the Up loops were too far away for conventional point rodging. A continental system of wire operated points was used instead. Here the barrel type levers are shown. Motor points replaced these wires shortly before the box closed in 1978. They had a reputation amongst older signalmen of being difficult levers to operate.

need for two boxes. The LMS developed a variation of the turnover levers to do this, including facing point locks of course, and installed a number of sets in the 1930s, of which Lindal was one. The problem with such installations, where there is only one

set on a district, is familiarity of the local people in operating and maintaining them, and the difficulty of obtaining spare parts. Hence over the years they all disappeared through replacement or box closures. In the early days the Midland also had a very

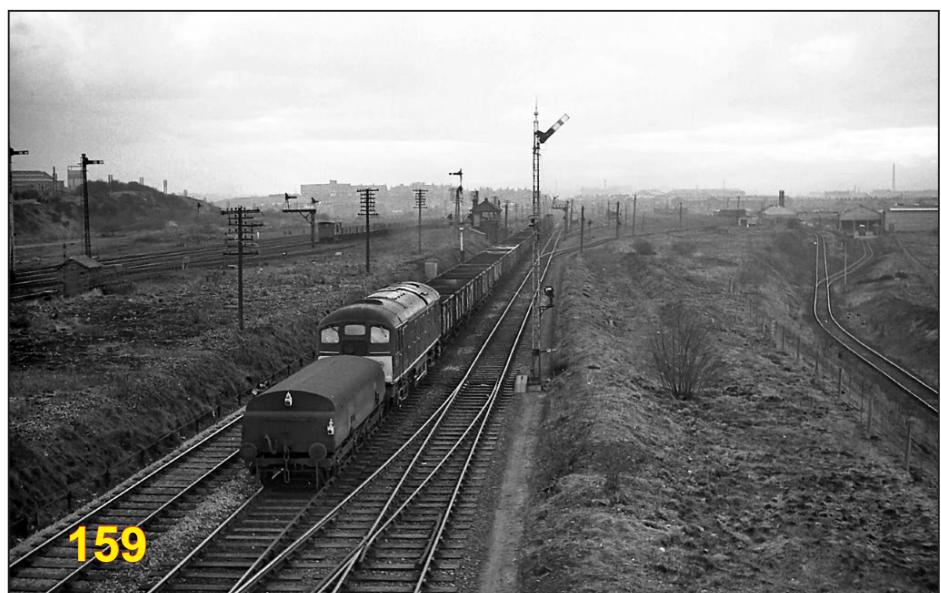
Challenge No. 159

Graham Worsnop advised that the photo was taken by Peter Robinson (046b06) of a BR Class 24 with brake tender passing Durranhill on a goods train to Tyne Yard in March 1966.

The track layout and signalling confused Les a little, as it looked as if the loco with its brake tender was pushing the train towards Carlisle. However, John advised that the train was heading towards Newcastle, and the line to the right was effectively a goods loop and the exit from London Road High Yard — it ends in a buffer stop up against Durranhill Road bridge, from where the photo was taken. John pointed out that the signal in the photo controlled the main line, and it looked to have a subsidiary signal for controlling the exit from the loop. **David Hunter** commented that he had never realised that the lines on the far right ever existed. **Ken Harper** added that in Steven & Jeff Davidson's book 'Rails Across Carlisle' there is a photo taken from an aeroplane (in 1968) of the 1956-built Metal Box Factory (Botcherby) which shows the railway connection from London Road High Yard. The text states that 'Railway works include the construction of an embankment from the main line sidings for nearly 1 mile of track, and there is a turntable for the turning around of wagons inside the factory'.

The Diesel Brake Tender (DBT) caught **Howard Quayle's** eye and he wondered if it was from either Gateshead's or possibly Thornaby's allocation, adding that he had only ever seen one image of the DBT inserted between the loco and train. A discussion on Facebook added that the DBT was attached to help increase brake force available to the driver on unfitted freight trains, as otherwise the only brakes would be those on the loco and the guard's van. **David Gibson** added that the brake tenders were semi-permanently coupled to the loco, so they could be pushed or pulled. David added that the tender in the photo is a Diagram 1/555, which ran on Gresley bogies reclaimed from redundant coaching stock. When built they were fitted with screw couplings, later replaced, as in the photo, with a three-link and an instruction written on the bodyside that 'Coupling of attaching vehicle to be used'. There was also a recess above the right hand buffer at one end which housed a screw coupling for emergency use. The tenders were filled with scrap metal and concrete to improve braking power. None were preserved, but a replica has been built by Railway Vehicle Preservations (RVP) Ltd and runs on the Great Central Railway. The photo

was taken from the NER overbridge at Durranhill, built to replace the level crossing at that location when the Midland line was constructed in the early 1870s.

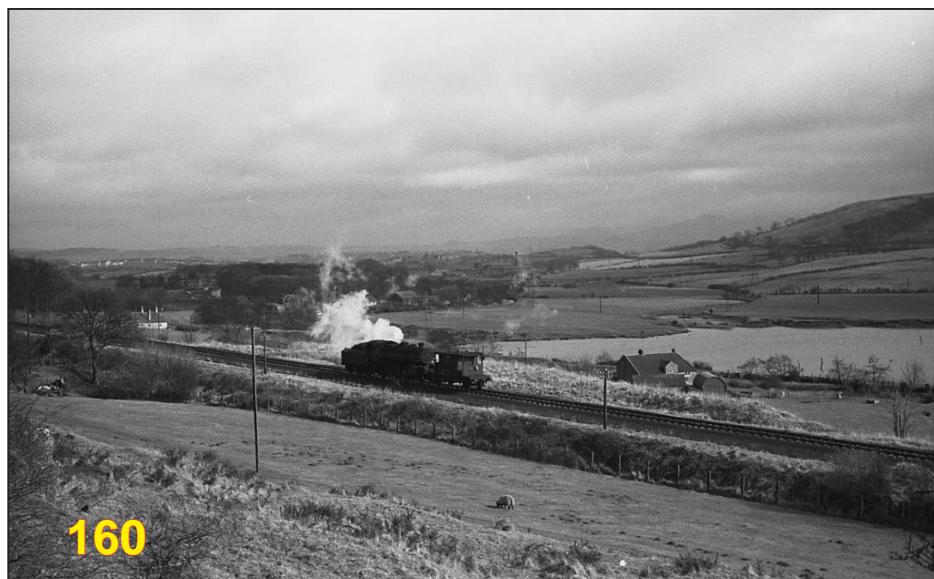
Challenge No. 160

Graham Worsnop advised that the photo was by Peter Robinson (9046b08) taken south of Woodend of LMS 4MT 2-6-0 on a local trip goods on 11th March 1966.

Peter Atkinson was confident that the location was just to the south of Woodend with Longlands Lake behind and a tree-free Dent. **Howard Quayle** asked if the 'former CRA member' was the late Martin Willey, whose family home backed diagonally across the track onto Woodend station. **Graham Worsnop** confirmed this. **Allan Beck** thought that the loco was one of Workington's 4MTs and agreed with Peter that it was south of Woodend Station.

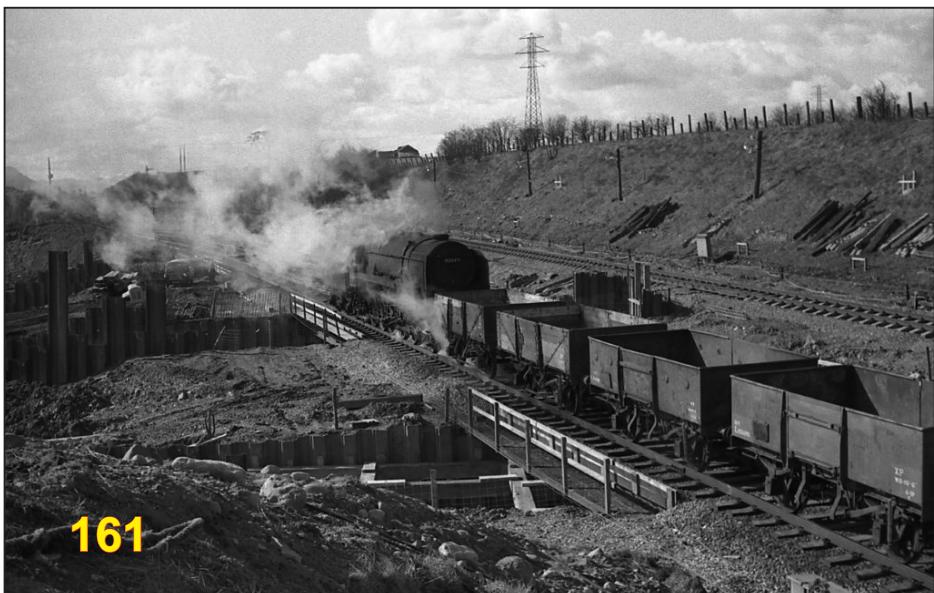
Challenge No. 161

Graham Worsnop advised that the photo was taken by Peter Robinson (047c07) of a BR 9F 2-10-0 No 92043 just south of Penrith whilst it was working a trip goods for the M6 motorway works. The photo was taken on 12th March 1966.

Ken Harper added that the location is about 200 yards south of where he started his BR career on 3rd August 1965, and, in the same week, the Irish contractors arrived to set up the site to construct the M6 bridge. They lodged in old coaches stabled on a siding where the car park for 'Home Bargains' is now. The Challenge photo shows the progress some eight months later, on 12th March 1966, which was a Saturday and he was on duty 12 hours (07.00 - 19.00) in Penrith No. 1 box. Ken thought the train may have been

the Carlisle Yard to Harrisons Sidings trip working, although it may also have been a ballast train unloading material for the bridge construction. If the latter, it would have been working between timetabled trains, and, as it was within Penrith No. 1's station limits, it would have been able to set back into the yard when necessary.

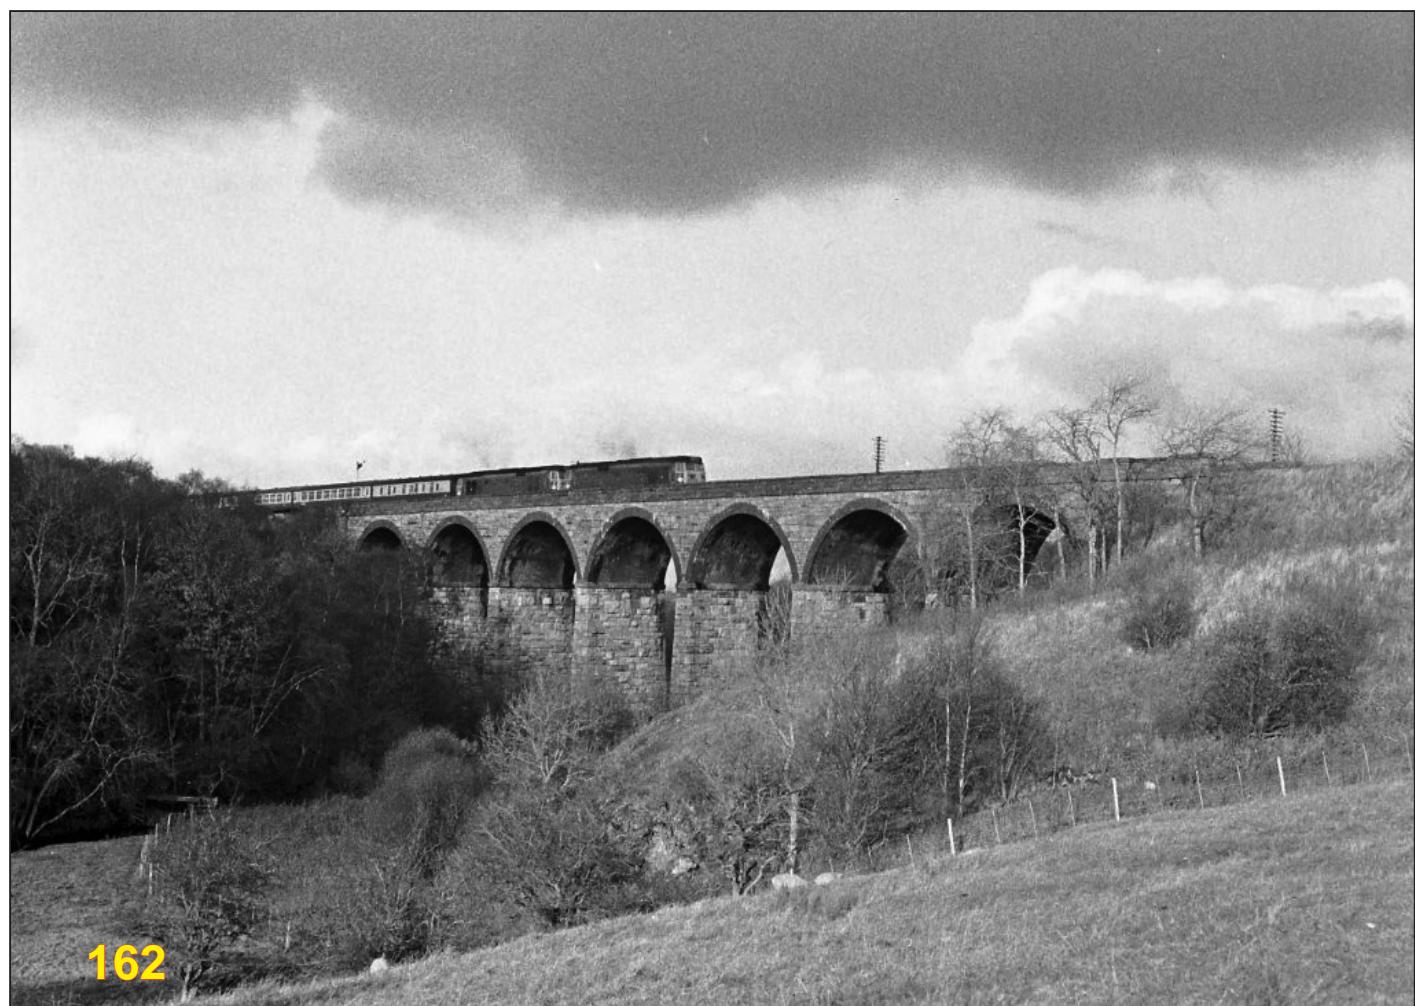
Challenge No. 162

Graham Worsnop advised that the photo was taken by Peter Robinson (A38c07) of two BR Class 50s with a diverted WCML express at Griseburn Viaduct in 1972.

looking for the location, and, after ruling out viaducts on the WCML in the Penrith area, suggested the picture showed Griseburn viaduct on the Settle & Carlisle line with a diverted WCML train crossing. **Peter Smith** agreed and believed it would most likely be a Sunday in the early 1970s when services were routed from the WCML over the Midland whilst electrification and modernisation work took place. Peter advised that the 1971/1972 timetable showed that 1M35 09.55 Glasgow to Euston, 1M19 11.55 Glasgow to Euston and 1M46 13.55 Glasgow to Euston were

Ken Harper added that the viaduct wasn't the most photographed on the S&C and that the 'Griseburn Ballast Sidings' nameboard seemed to take up the full length of the front of the box, and other than 'Derwent Haematite Ironworks' he asked if there were any longer signal box names in the county. **Geoff Holme** noted that the shortest in the county would have been Cark, which was abolished in 1998.

Ken also asked if the small quarry opposite Griseburn box was opened to supply ballast for the construction of the line. **David Hunter** advised that according to Anderson & Fox's book 'Stations and Structures of the Settle & Carlisle Railway', the sidings opposite the box were used to quarry stone for use as ballast on the railway from the late 1880s until World War I. The diagram in the book, which was dated 1912, shows a Blacksmith shop (disused) and a couple of sidings with the quarry located behind.

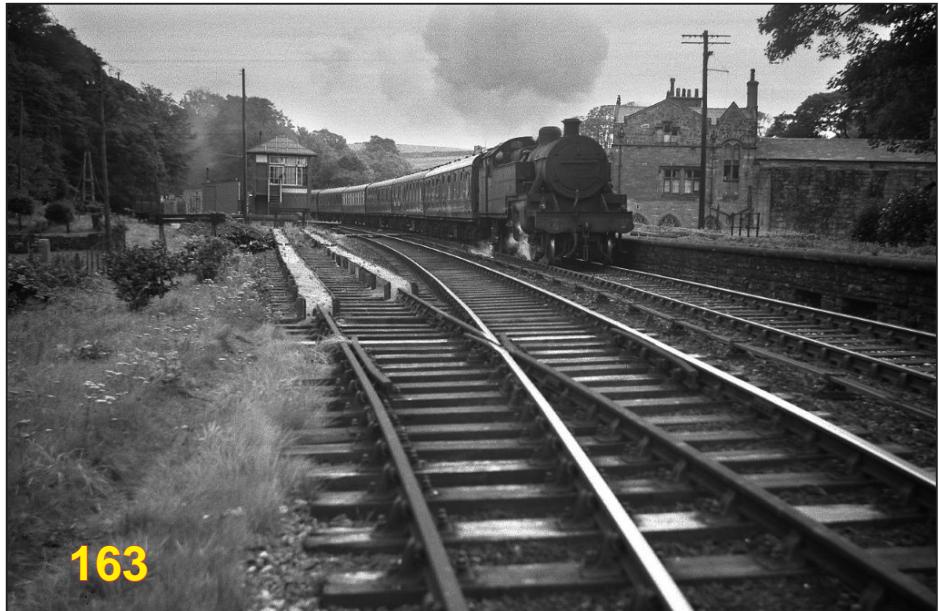
Challenge No. 163

Graham Worsnop advised that the photo taken by Bill Worden (WOR051) was of LMS 4MT 2-6-4T No 42367 working an Up Passenger service past the temporary signal box and former station at Furness Abbey, dated 1958. **John Pickup** wasn't sure about the loco details being correct as 42367 was one of the Fowler 2-6-4Ts which had a simple cut-out window with no glazing, whereas the loco in the photo seemed to be one of the later locos which had a side-window cab. John added that in 1958 No 42367 was allocated to Willesden so he didn't think that this was the loco pictured at Furness Abbey. **David Stubbins** advised that the handwritten list provided by Bill showed the photo recorded as 'Class 4 tank No 2376 at Furness Abbey in 1958'. After further thoughts regarding the loco's side window arrangement, the discussion ended without a definitive answer to the

As we discussed in a previous Challenge, Richard confirmed that the box at Furness Abbey was there as part of the tunnel works between 1956 and 1959. **Peter Holmes** reminded us that the Up and Down lines were interlaced through the tunnel while the re-lining work was being done. The box was a temporary one on the former island platform. Peter

thought that the siding joined the Up line and crossed the Down line by a single slip, but the curvature of the siding in the photo gives the impression of a simple facing connection with the Down line. Peter also confirmed that the box was the one at Furness Abbey.

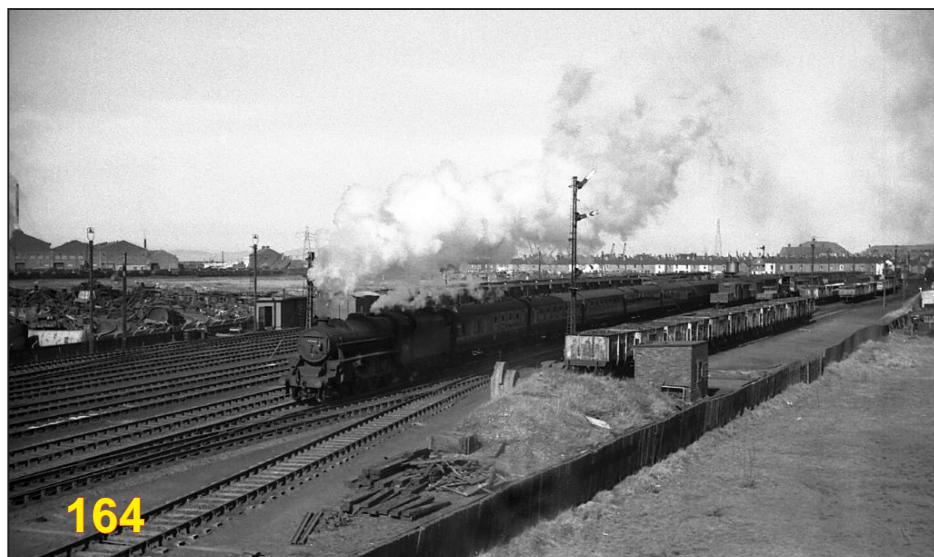
Challenge No. 164

Graham Worsnop advised that the photo was taken by Peter Robinson (047d14) of LMS 5MT 4-6-0 No 45364 working the 13.03 Workington to Manchester Victoria south of Workington on 18th March 1966.

Dave Stubbins and **John Pickup** agreed that the loco was a 'Black 5' with the number beginning with '44', and that the loco had a 'forward top feed' boiler that had originally been fitted to locos numbered below 44800 — though some were moved to earlier engines during major overhauls, especially those engines that had been repaired at St Rollox. **Andrew Naylor** was able to identify the loco as No 45364, which **Tony Jenkinson** advised was a Workington and Kingmoor loco in the 1960s, and when it was built in 1937 it would have had a boiler with sloping throat plate and the top feed position immediately in front of the dome. Tony added that St. Rollox

works was known to have swapped boiler types on Class 5s more often than English workshops. In some photos from 1963, No 45364 is shown fitted with a bufferbeam-mounted snowplough, although by 1966 this had been removed. **John Pickup** agreed that the loco was 45364 and added that the forward top feed boiler was done during a General Repair ending on 9th December 1961. John did find it a bit odd that the loco modification was done while it was allocated to Workington. It had moved there from Kingmoor in March 1961 and it went back to Kingmoor in March 1963. **Tony Jenkinson** discovered that St. Rollox Works was regularly repairing Kingmoor Class 5 engines, even after the depot was transferred from the Scottish to the London Midland Region. This continued up until mid-1962, and from then on the (decreasing) number of steam locomotives receiving attention there were almost all from depots in Scotland — with an

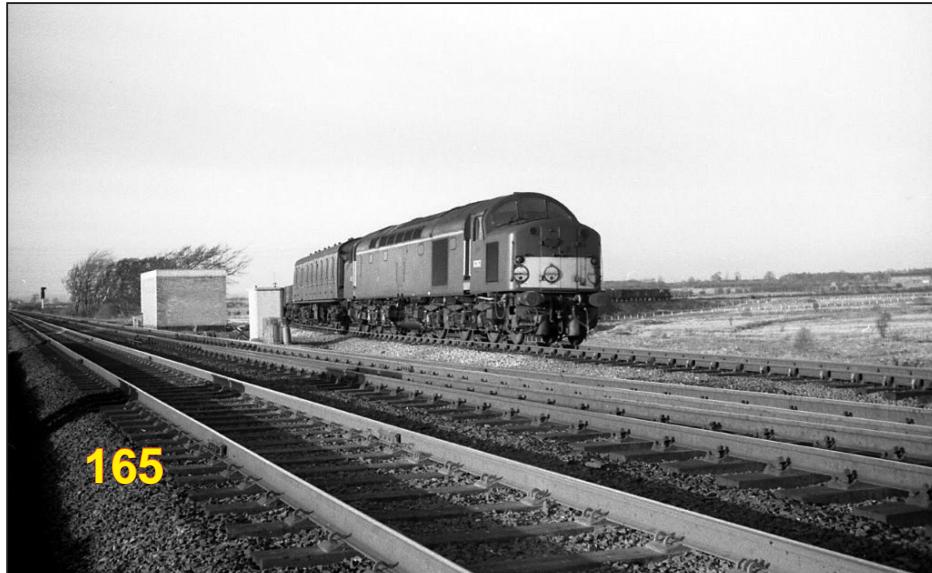
Challenge No. 165

Graham Worsnop advised that the photo was taken by Peter Robinson (041b09) of a BR Class 40 bringing an Up Goods off the Longtown chord at Mossband Junction in October 1965.

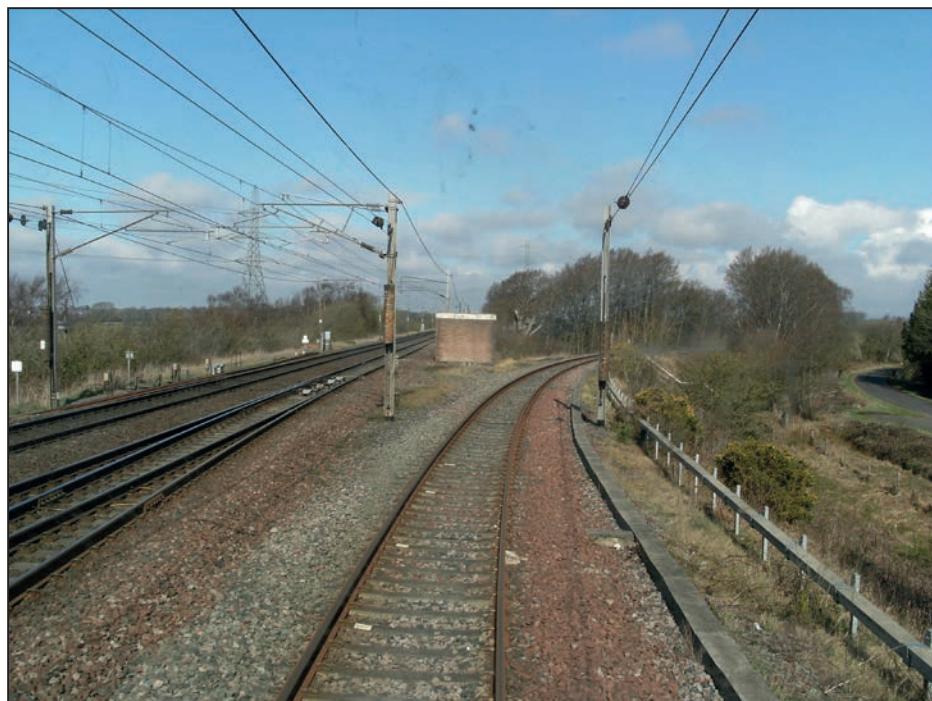
Mossband Junction taken on 31st March 2016 from the cab of 66221 whilst working the Longtown trip. The junction on the left is the point where the Up Goods diverges off the Up Main, whilst the branch curves off to the right. The brick building is still in the same location.

David Hunter posted a photo of Mossband Junction taken in 2016 during a cab ride to Longtown MOD. Apart from a few more trees along the lineside, very little had changed.

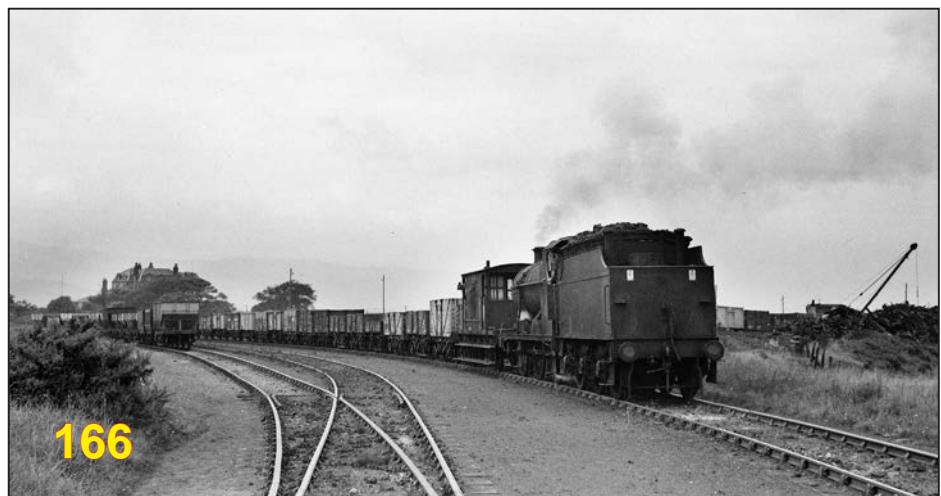
Challenge No. 166

Graham Worsnop advised that the photo was by Pearsall (PES362) of LMS 4F 0-6-0 No 44487 shunting at Hodbarrow on 19th July 1961. **Tony Jenkinson** added that the photo's location appeared to have been close to the access drive to Millom UDC's 'Infectious Diseases Hospital', a reminder of previous attempts to ward off pandemics.

Derrick Codling's access to Google Translate appeared to be limited but **Ron Herbert** confirmed the location as Crab Marsh on the Hodbarrow branch. **Peter Holmes** agreed, adding that the camera position was around grid reference SD189796 facing north-west, with Duddon Villa in the background, Millom Ironworks just out of sight to the left, and 'The Pier' on the right.

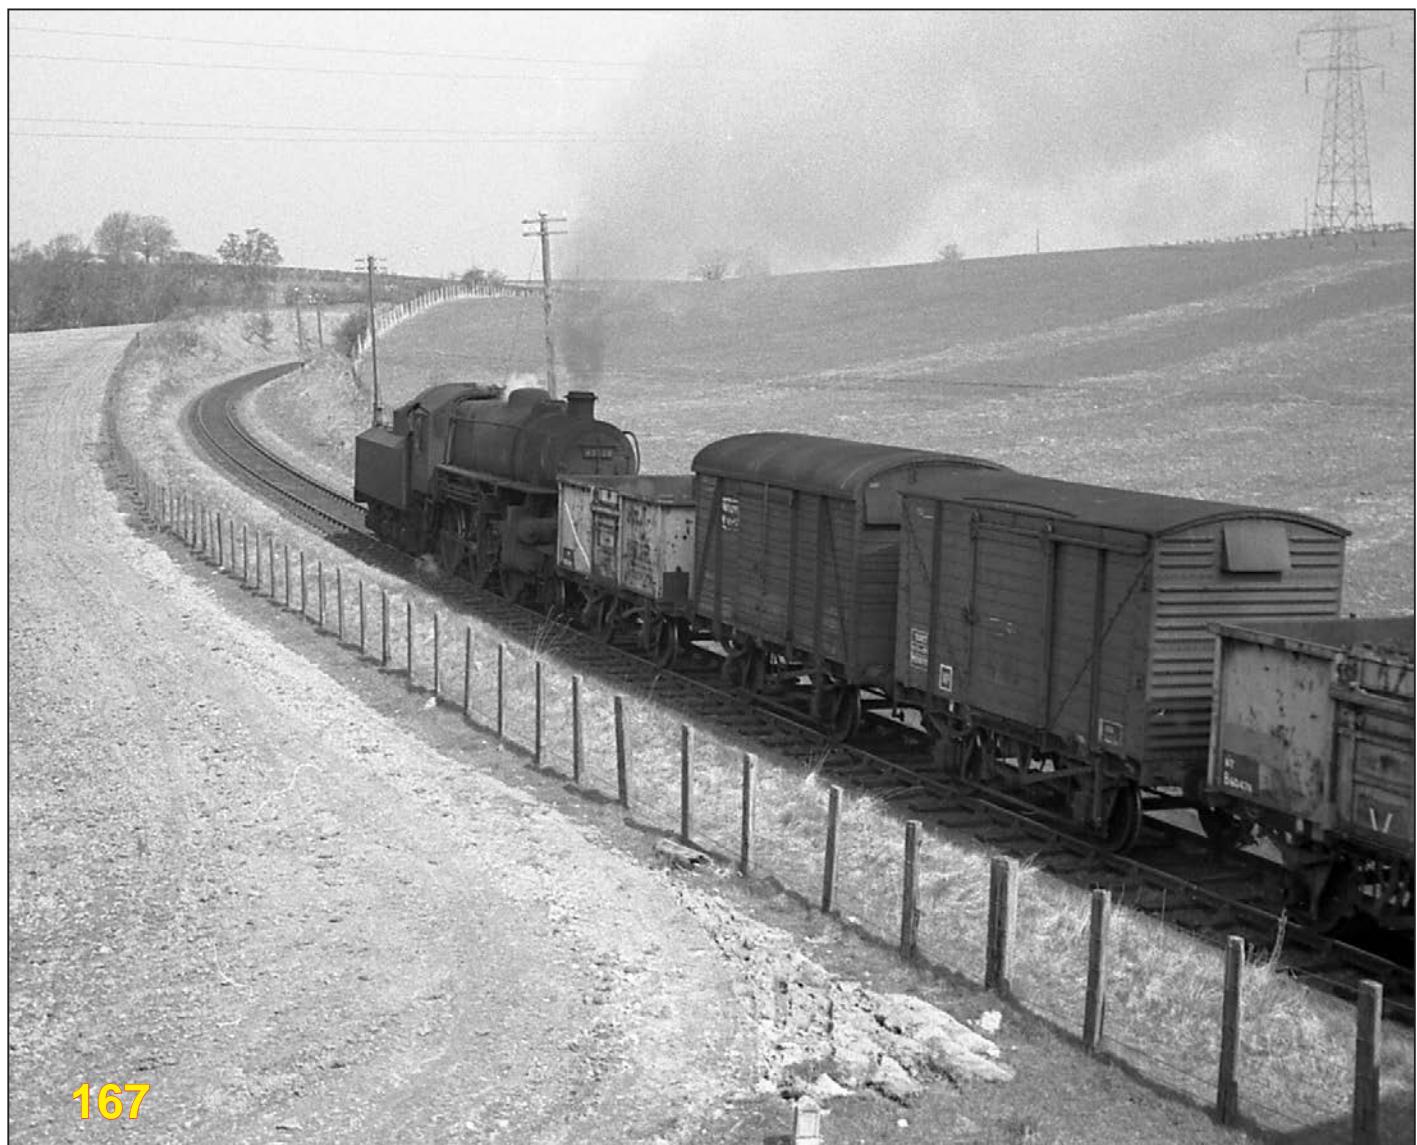
Challenge No. 167

Graham Worsnop put everyone out of their misery and congratulated Eliot on his detective work by confirming that the photo was taken by Peter Robinson (051e15) of LMS 4MT 2-6-0 No 43028 south of Gilnockie whilst working a Longtown goods trip on 2nd May 1966.

on the C&WJR main, heading towards High Harrington as the line was double tracked and also the climb from Bain's Siding to Lowca, Eliot picked up on the propensity for a play on words in the caption with the word 'country' and wondered whether it was a cross-border railway. Having looked further at some maps, Eliot believed that the photo was taken on the Langholm branch, just north of Canonbie, with the train heading north. **John Pickup** agreed with Eliot and thought the date of the photo would be from 1963 onwards, as the second vanfit has the 'boxed' style lettering, which he believed was introduced then or in 1964.

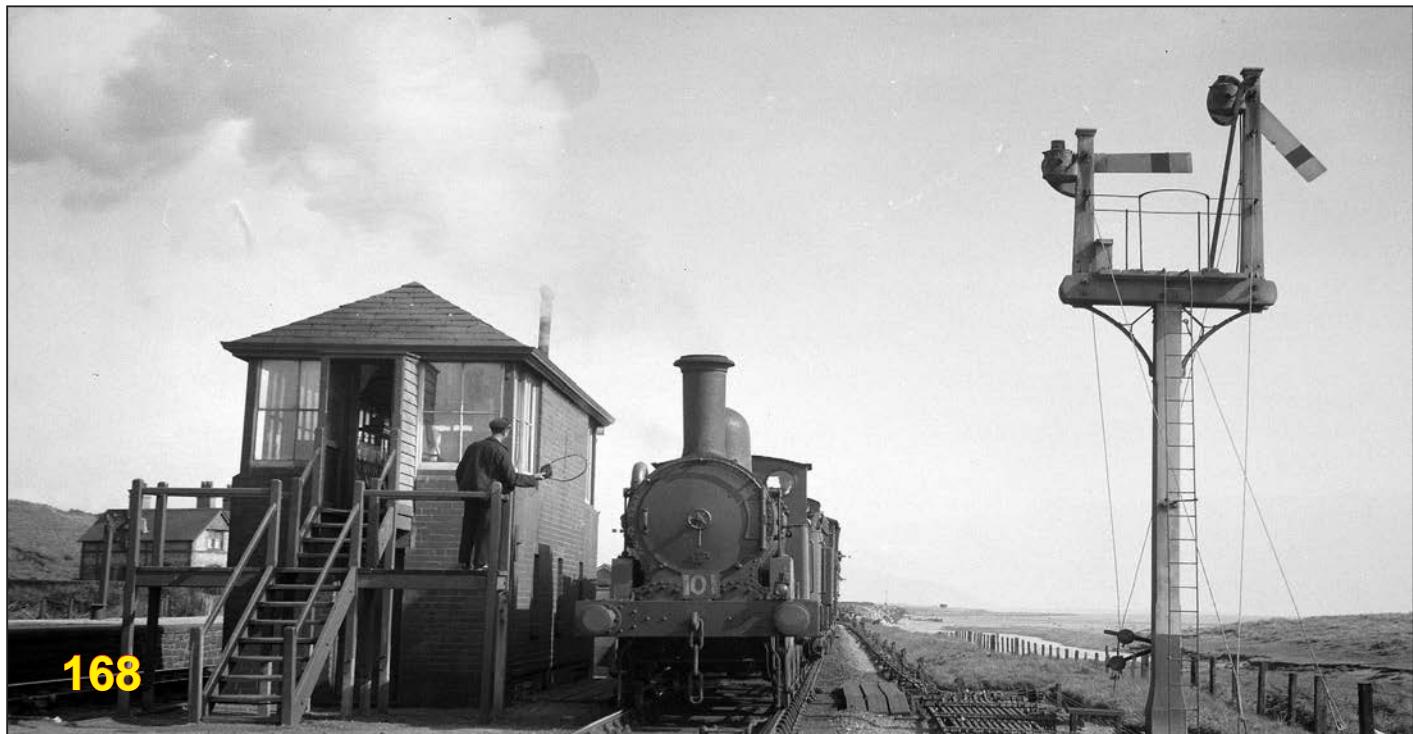
Challenge No. 168

Graham Worsnop advised that the photo was by Pattinson (PAO190) taken in 1935 at Sellafield station of LNWR 18in 0-6-0 approaching the box to pick up the single line token.

Sellafield between 3.05pm and 3.15pm and running via Nethertown and St Bees. Howard noted that this was the only Down Class G working which served Sellafield, and added that the light in the photo would seem about right for the time of day. Taking note of the '101' disc on the front of the loco, **Ron Herbert** checked the Barrow District Trip book for 1953 as well as the WTTs for 1955 and 1956, but found that Target 101 wasn't used or shown, suggesting that Howard was probably right in the fact the photo was taken earlier. **John Dickie** thought the photo was more likely to have been taken either pre-, or possibly immediately post-World War II, as the loco appeared to be an ex-LNW Cauliflower.

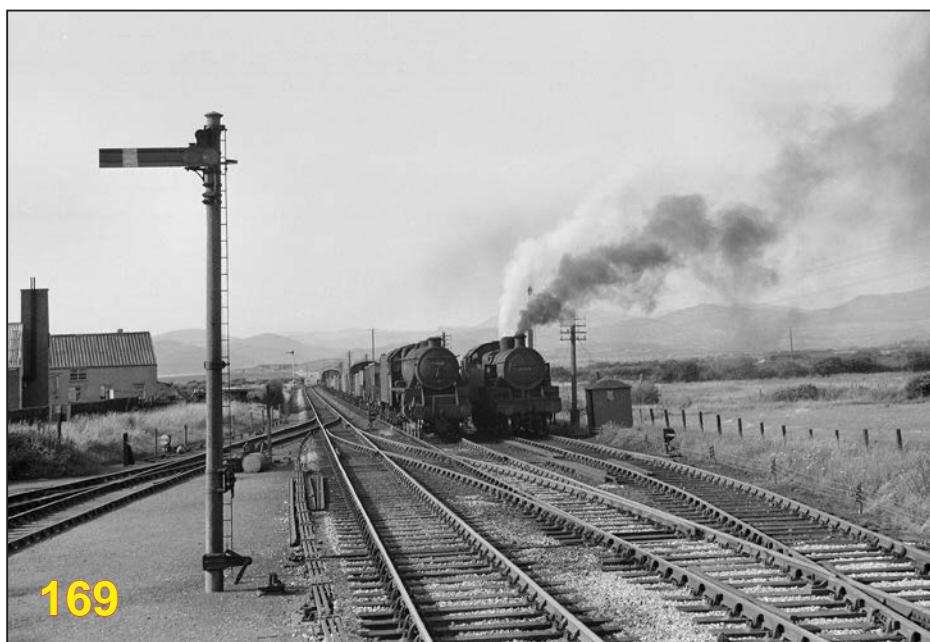
Challenge No. 169

Graham Worsnop confirmed that the photo was by Pearsall (PES369) taken at Askam of LMS 5MT 4-6-0 No 45000, which has stopped alongside 4MT 2-6-4T No 42345 ready to bank the 1.25 pm Workington to Carnforth goods to Park. The photo is dated 19th July 1961.
